SUBJECT: Site Inspection, Quality Building Stone, Unpermitted Quarries,
M/055/022, Wayne County, Utah

Date of Inspection: March 18, 2004
Time of Inspection: About 12:00 to 2:00 and 5:00 to 6:30 PM
Conditions: Mostly sunny, 60's
Participants: Wes Hansen and Dan Powell, Quality Building Stone; Buzz Rakow, Hanksville BLM; Paul Baker, DOGM

M/055/022, Quality Building Stone, Unpermitted Quarry
Inspection Dated: March 18, 2004; Report Dated: March 26, 2004

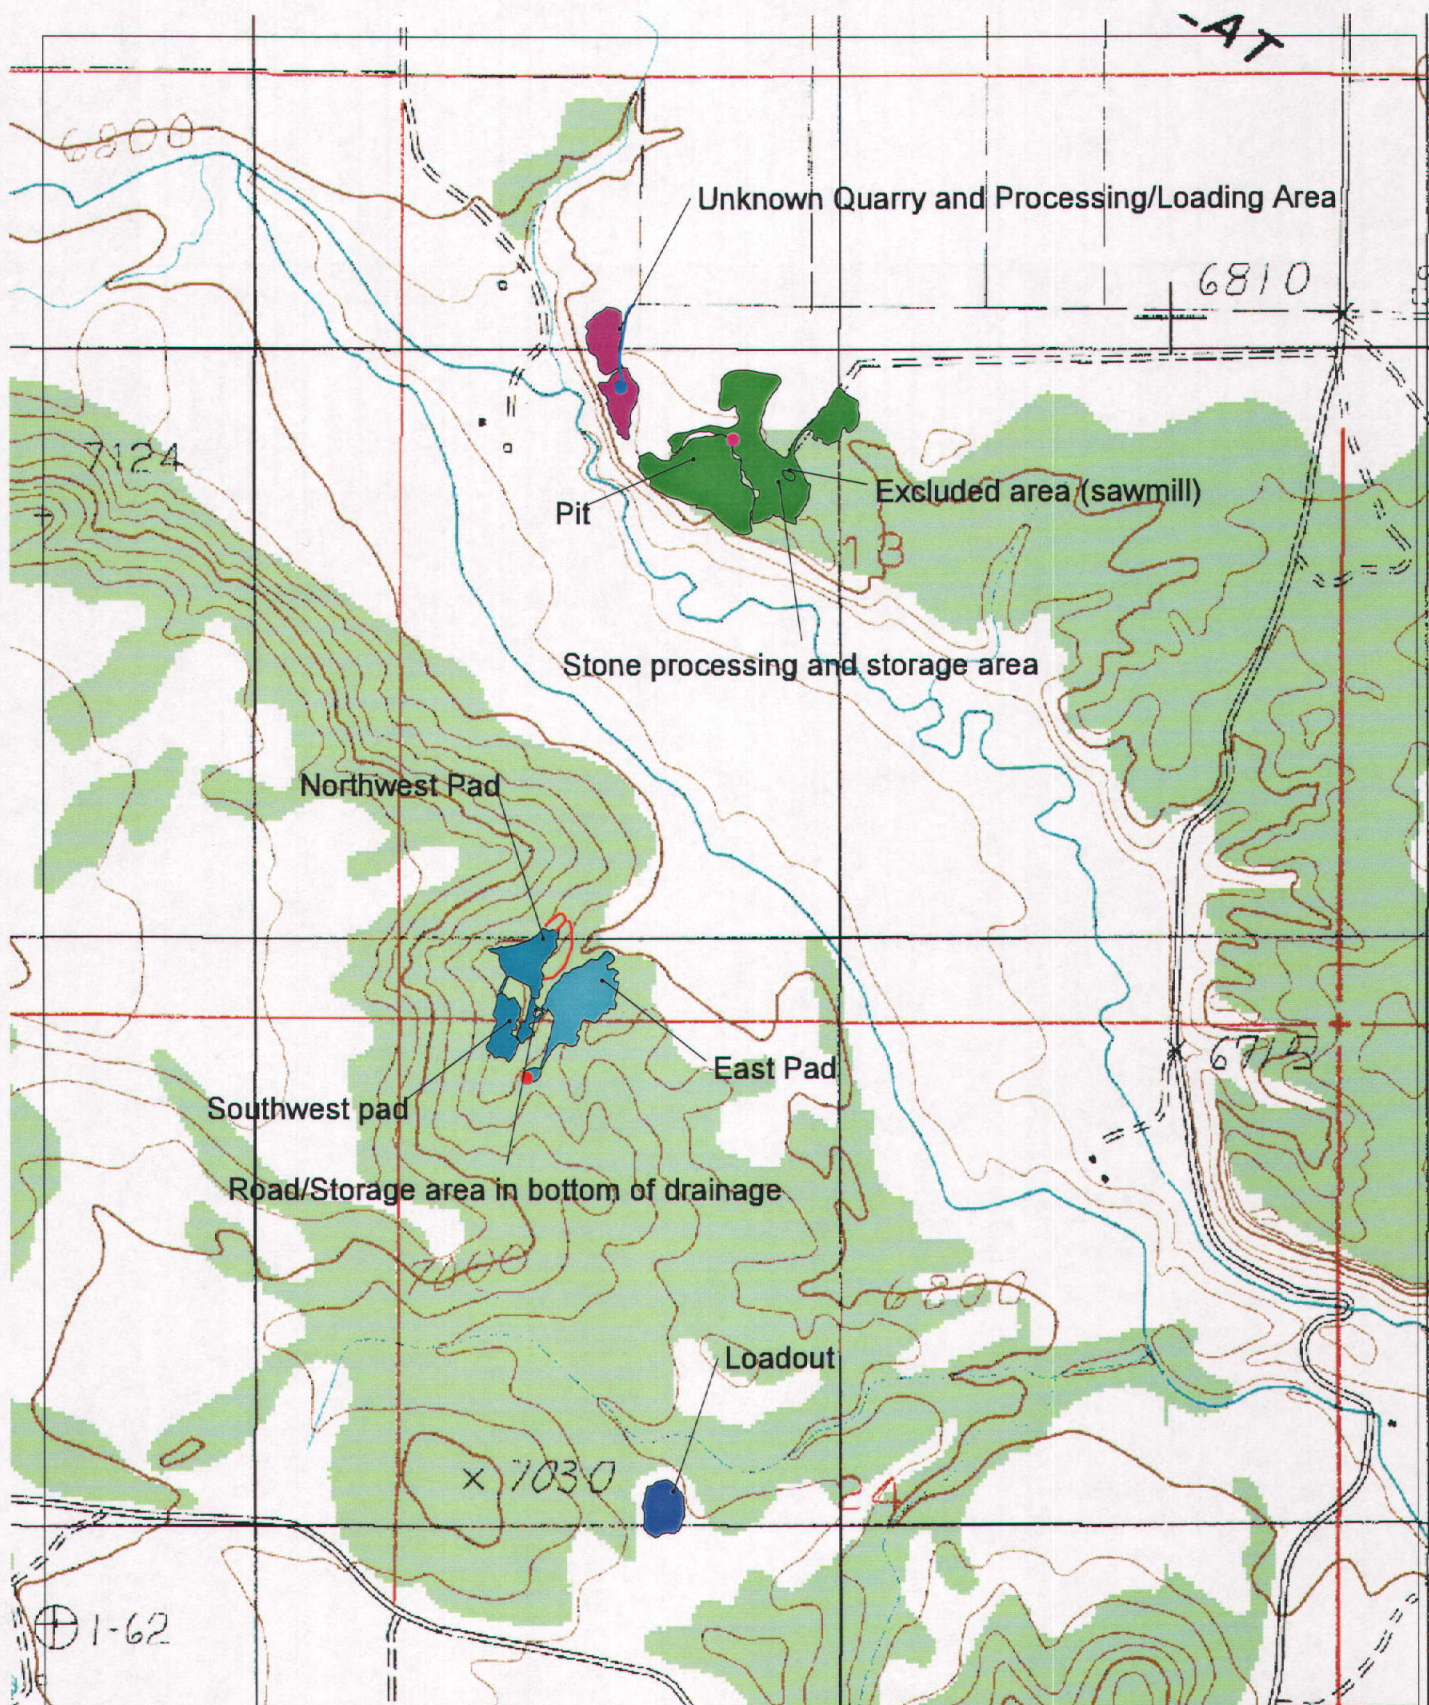
On the south side of the pit, waste material has been graded to the south toward the Fremont River. On the east side, the waste forms a slope extending to the flat alluvial terrace below (Photo 8), but on the west, it goes just down to the top of a cliff, at least as far as I could see (Photo 6).

Photo 8. This is where the overburden outslope extends to the valley floor and is just to the east of the area shown in Photo 6.
